# UNDERWATER BRIDGE INSPECTION REPORT

STRUCTURE NO. 4260

CITY ROUTE 154

NORTH CHANNEL OF THE MISSISSIPPI

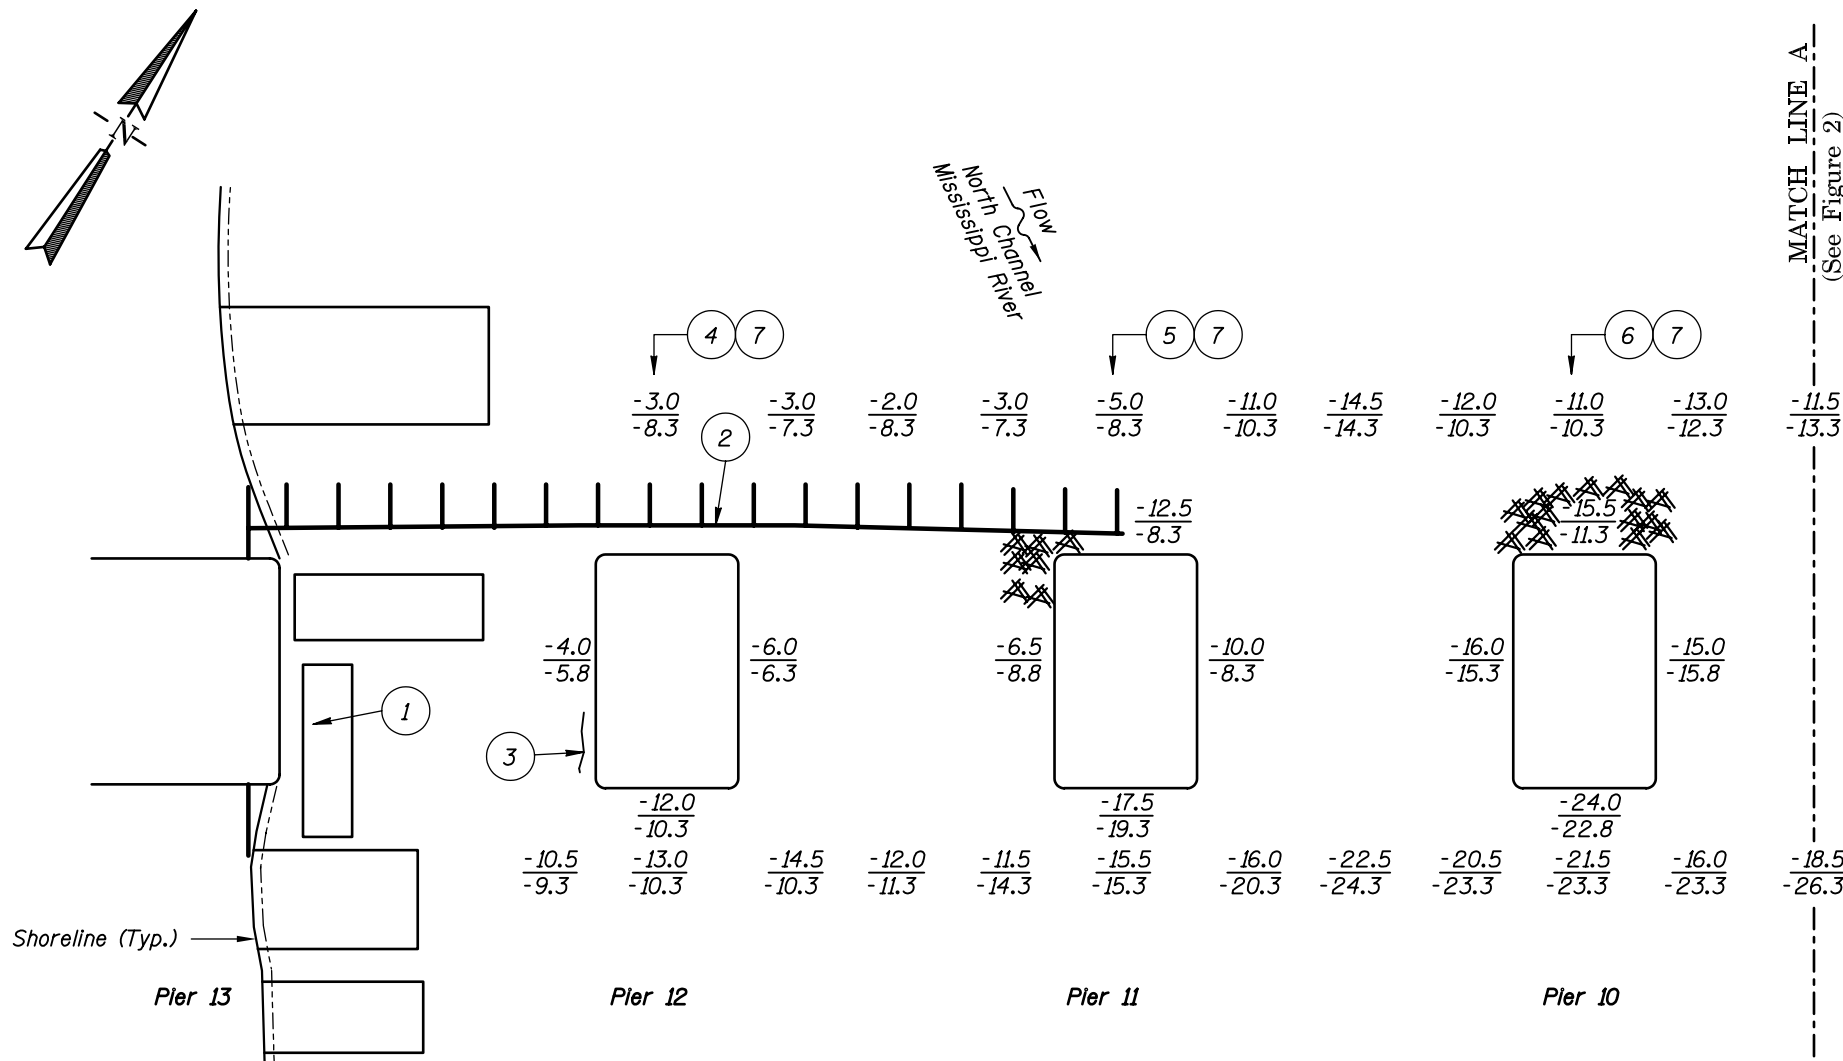
**INSPECTION AND SOUNDING PLAN**

- 1 Pier 13 was inaccessible due to the presence of pontoon boats and house boats which were blocking the area.
- 2 A framework of timber planks was lodged against the upstream noses of Piers 11, 12, and 13.

- 3 The original timber formwork was observed along the downstream west face of Pier 12 and was loose from 4 feet below the waterline to the channel bottom.

- 4 The bottom of the footing at Pier 12 was located approximately 8 feet below the waterline. Vertical undermining was limited to the downstream end with 3 feet of undermining at the west corner and up to 5 feet at the east corner.

- 5 The bottom of the footing at Pier 11 was located approximately 11 feet below the waterline. A minor accumulation of timber debris was observed on the channel bottom at the upstream west corner. The rest of the footing exhibited undermining with 3 feet of vertical undermining at the upstream east corner, 6 feet at the downstream west corner and a maximum of 7 feet at the downstream east corner.

- 6 The bottom of the footing at Pier 10 was located approximately 12 feet below the waterline. A minor accumulation of timber debris was observed on the channel bottom at the upstream end. The entire footing exhibited undermining with 3 feet of vertical undermining at the upstream east corner, 4 feet at the upstream west corner and a maximum of 12 feet at the downstream end. Three of the timber piles along the edge of the northwest corner were no longer encased in the concrete footing.

- 7 The submerged concrete was typically in satisfactory condition with moderate scaling from the waterline to 2 feet below the waterline with typical penetrations of 1/2 inch and maximum penetrations of up to 1 inch. Random vertical and horizontal hairline cracks were also observed on the submerged concrete. Typically, the exposed timber piles exhibited 5 to 10 percent section loss unless otherwise stated.

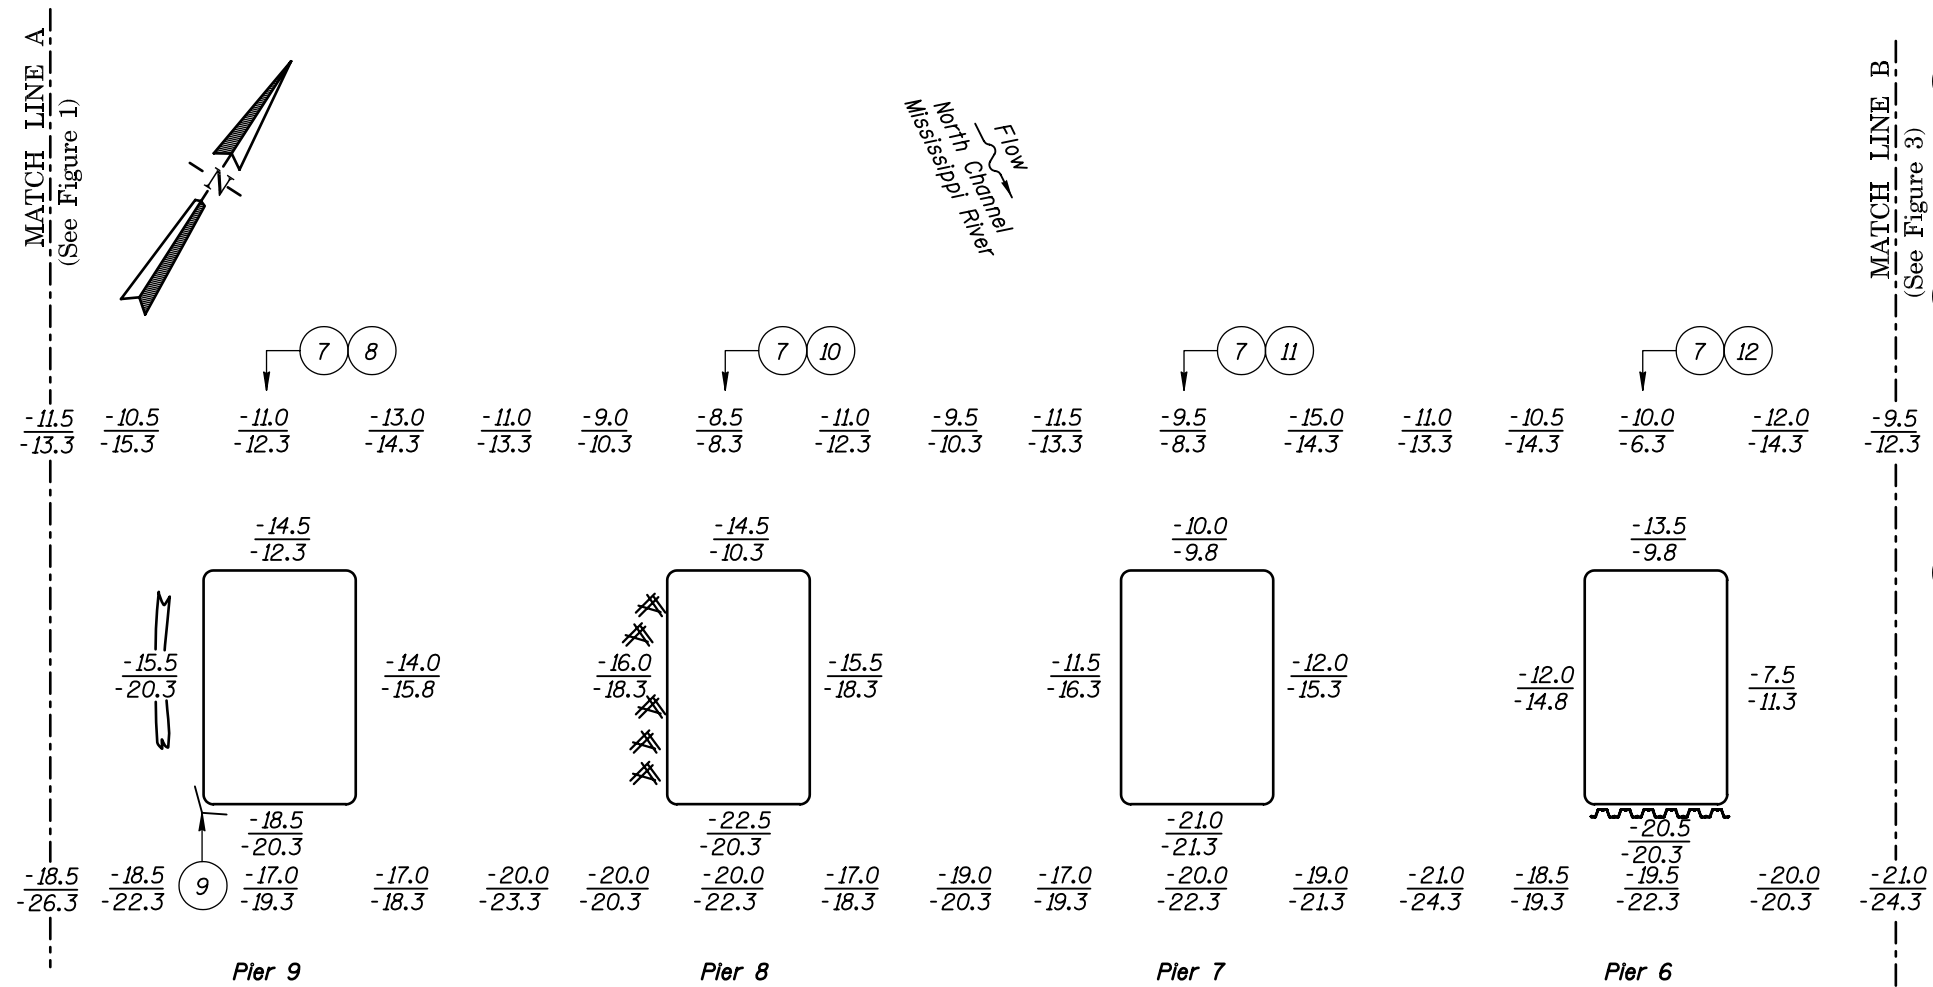
SOUNDING PLAN

- 8 The bottom of the footing at Pier 9 was located approximately 10 feet below the waterline. A tree that was 2 feet in diameter and 30 feet long was observed on the channel bottom along the west face of the pier. The entire footing exhibited undermining with 4 feet of vertical undermining at the upstream east corner, 5 feet at the upstream west corner and the downstream east corner, and a maximum of 12 feet at the downstream west corner. Four of the timber piles at the downstream end of the pier exhibited up to 50 percent section loss and were loose in the concrete footing pocket.

- 9 Pier 9 exhibited an area of section loss on the downstream west corner from 1 foot above to 2 feet below the waterline with up to 2 inches of penetration.

- 10 The bottom of the footing at Pier 8 was located approximately 12 feet below the waterline. A light accumulation of timber debris was observed on the channel bottom along the west face of the pier. The entire footing exhibited undermining with 2 feet of vertical undermining at the upstream east corner, 3 feet at the upstream west corner, 10 feet at the downstream east corner, and a maximum of 11 feet at the downstream west corner. Four of the timber piles at the downstream end of the pier exhibited up to 50 percent section loss.

- 11 The bottom of the footing at Pier 7 was located approximately 11 feet below the waterline. No undermining was observed at the upstream end of the pier, however, the downstream end of the footing exhibited 9 feet of vertical undermining at the downstream east corner and 11 feet at the downstream west corner.

- 12 The bottom of the footing at Pier 6 was located approximately 12.8 feet below the waterline. No undermining was observed at the upstream end of the pier, however, the downstream end of the footing exhibited a maximum of 8 feet of vertical undermining. Timber formwork was observed along the east face of the pier, and steel sheet piling was observed 2 feet south of the downstream end of the pier and extended from the channel bottom to the top of the footing. The downstream timber piles exhibited up to 30 percent section loss.

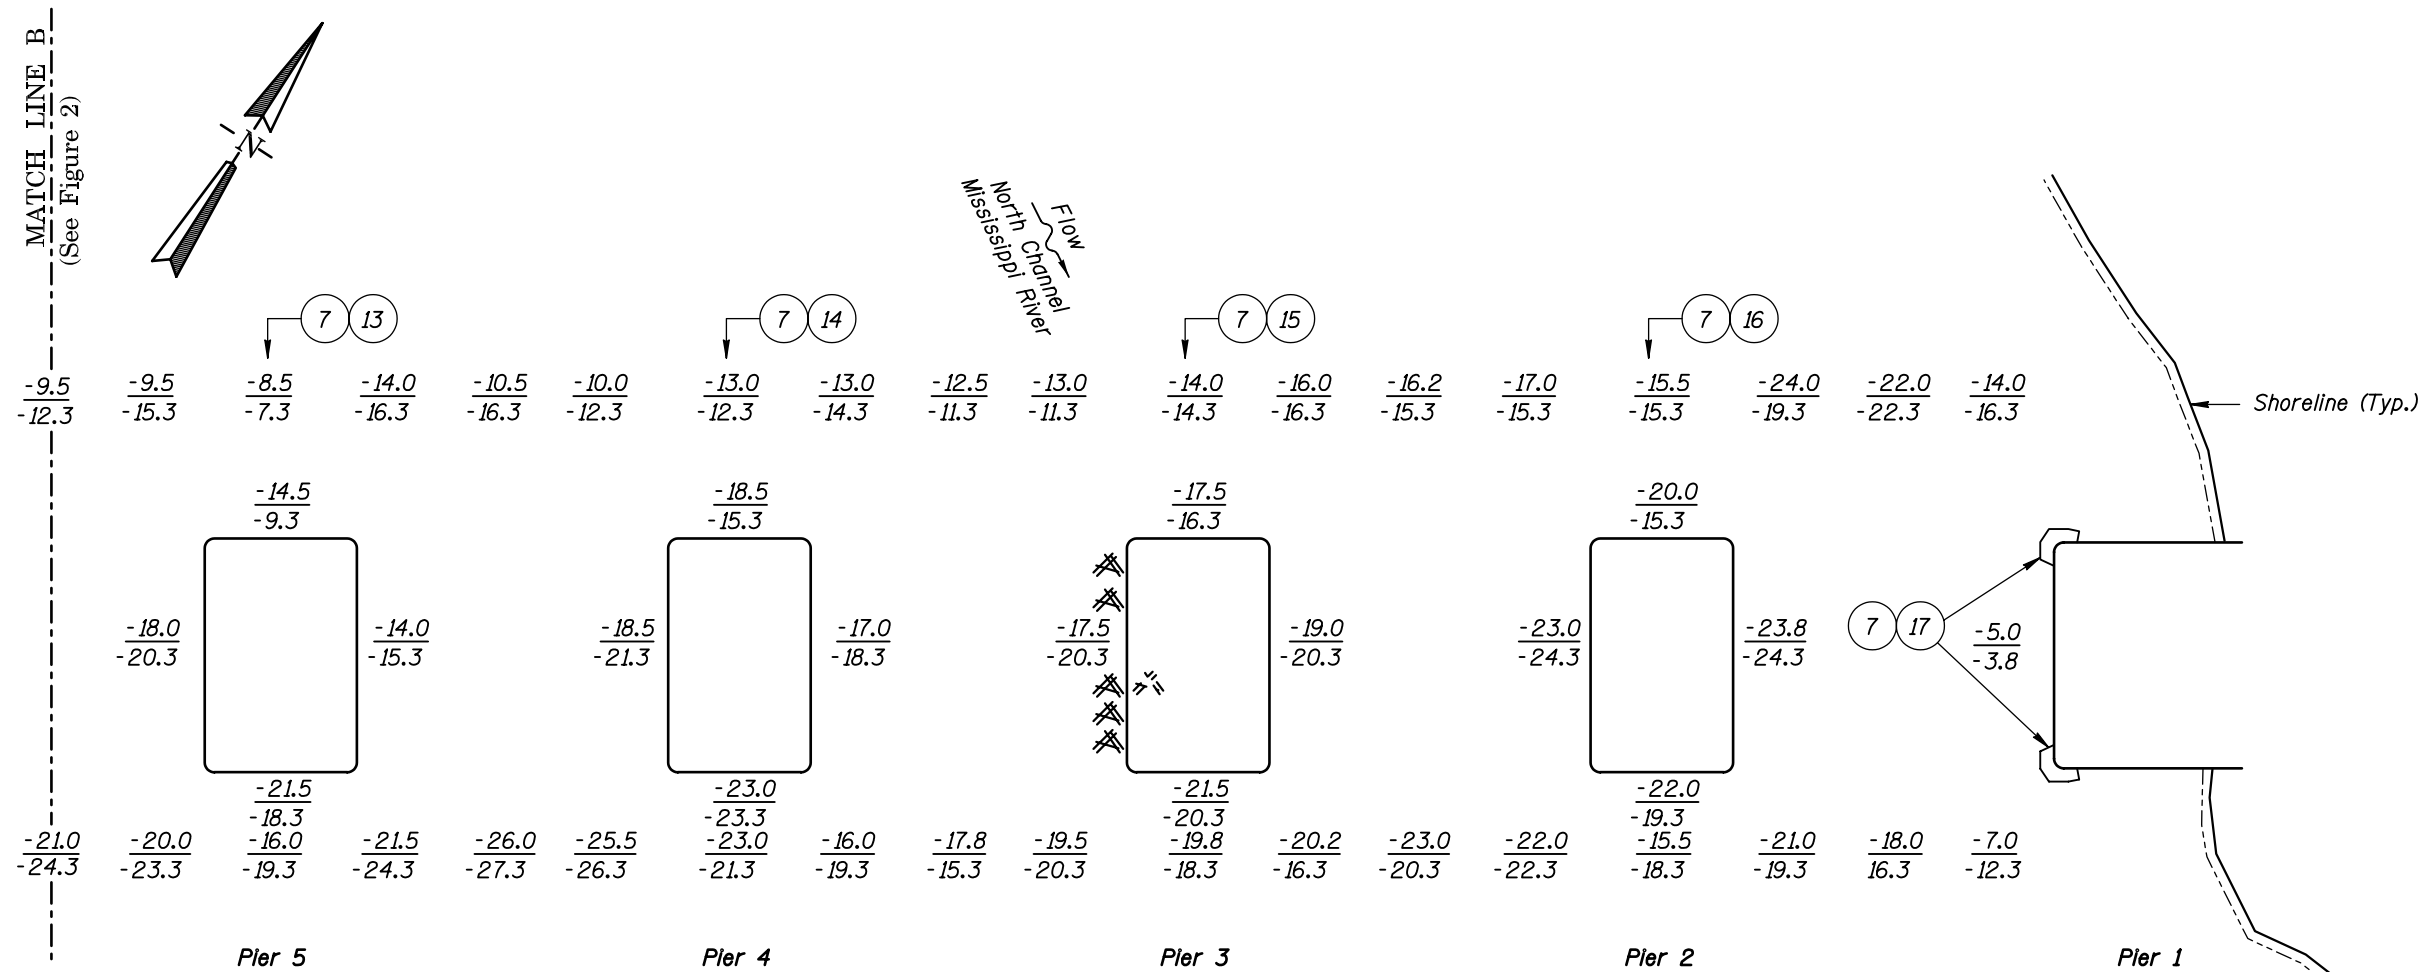
### SOUNDING PLAN

- 13 The bottom of the footing at Pier 5 was located approximately 12 feet below the waterline. The entire footing exhibited undermining with 2 feet of vertical undermining at the upstream west corner, 3 feet at the upstream east corner, 9 feet at the downstream west corner, and a maximum of 10 feet at the downstream east corner. The bottom edge of the concrete footing exhibited section loss measuring 1 foot high and 1 foot deep along the entire west side of the pier. The downstream timber piles exhibited up to 25 percent section loss.

- 14 The bottom of the footing at Pier 4 was located approximately 12.5 feet below the waterline. The entire footing exhibited undermining with 6 feet of vertical undermining at the upstream end, 9 feet at the downstream east corner, and a maximum of 12 feet at the downstream west corner. The downstream piles exhibited 30 to 40 percent section loss, and the southeast corner pile was broken at 2 feet above the channel bottom. The concrete footing exhibited a 2 foot high band of heaving scaling with up to 1 foot of penetration.

- 15 The bottom of the footing at Pier 3 was located approximately 12.5 feet below the waterline. The entire footing exhibited undermining with 5 feet of vertical undermining at the upstream end and 9 feet at the downstream end. A minor accumulation of timber debris was observed on the channel bottom scattered throughout the timber piles along the west side of the pier. The downstream piles exhibited up to 15 percent section loss.

- 16 The bottom of the footing at Pier 2 was located approximately 15 feet below the waterline. The entire footing exhibited undermining with 5 feet of vertical undermining at the upstream end and 7 feet at the downstream end. Typically, the downstream timber piles exhibited 20 percent section loss. The timber pile at the southwest corner exhibited 50 percent section loss. A band of heavy scaling was observed from 1 foot above to 2 feet below the waterline with up to 6 inches of penetration.

- 17 The top of the footing at Pier 1 was exposed at the upstream and downstream corners with up to 1.5 feet of vertical face exposure.

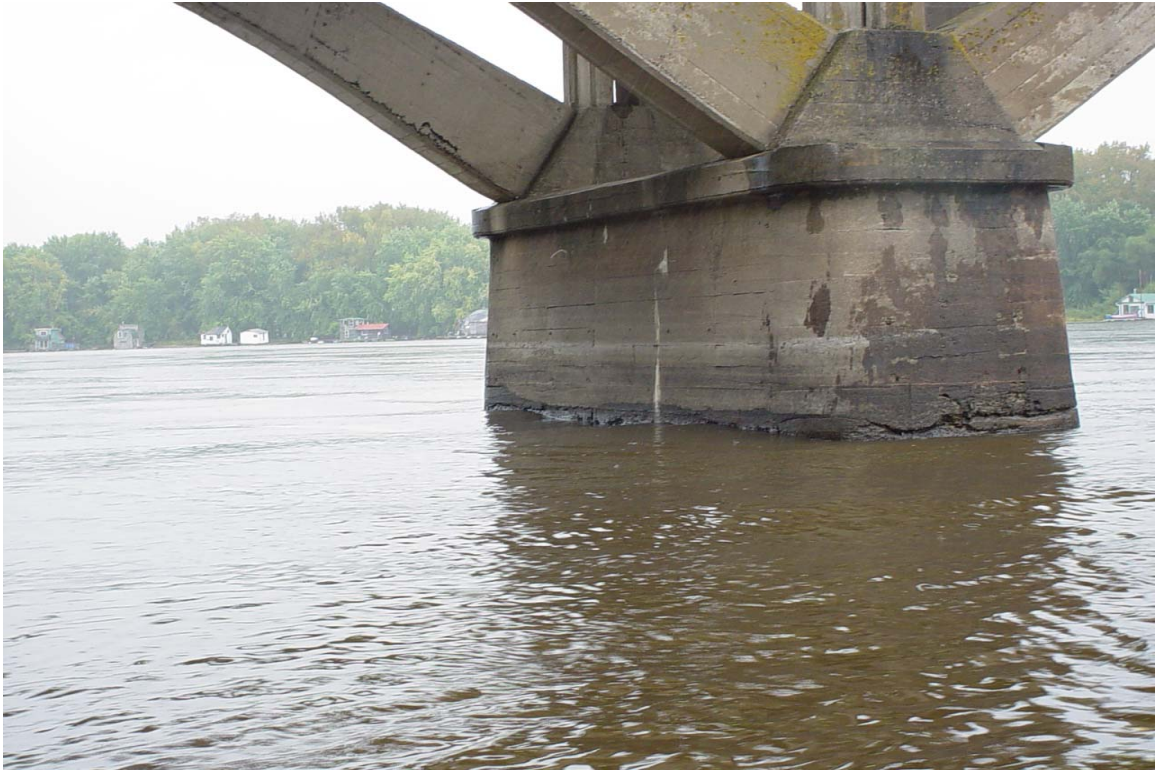
Photograph 3. View of Pier 2, Looking Southwest. Note Heavy Scaling at Waterline.

Repair the areas of concrete section loss by removing the unsound concrete and reforming with a concrete mix designed to promote high durability and low permeability.
